TEST REPORT

Report No. : 17-002214-03-2

Description : Capacitance type level switch

Model Name : SCAP-1-D-1-B

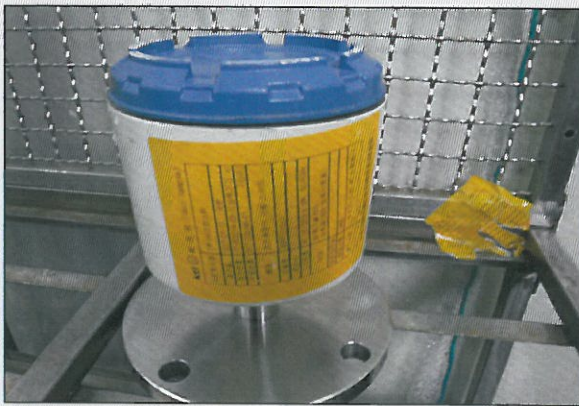
[Fig. 1: Head]

- Description : Capacitance type level switch
- Model Name : SCAP-1-D-1-B
- Dimensions : Diameter of 121 mm × 155 mm (head), 500 mm (rod)

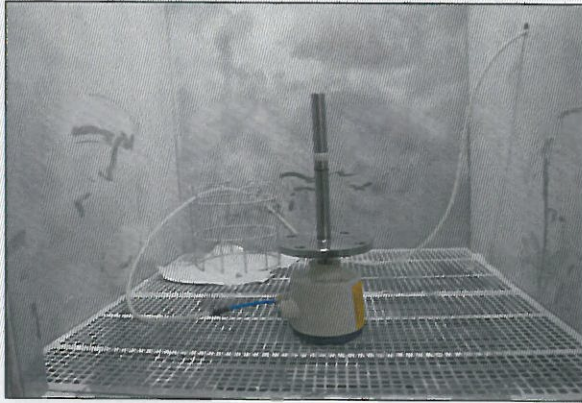
[Fig. 3: IP 6X]

Code Letters	IP	Conditions	Results
1st Characteristic numerals Against ingress of solid foreign objects	6	2.1 Dust Test Conditions <ul style="list-style-type: none"> Talcum powder(mesh) wire diameter: 50 μm Talcum powder(mesh) wire width: 75 μm Amount of talcum powder of the test chamber: 2 kg/m³ 	Pass

2.2 Dust Test Contents <ul style="list-style-type: none"> Volume of the enclosures: About 890 cm³ Reduction air pressure: -2.00 kPa (-200 mmH₂O) Flow rate: 0.10 L/min Extraction rate per hour: 6.74 volumes/h Test duration: 8 h 	
2nd Characteristic numerals Against ingress of water with harmful effects	6	2.3 Water Test Conditions <ul style="list-style-type: none"> Internal diameter of the nozzle: 12.5 mm Delivery rate: (100 ± 5) L/min Core of the substantial stream: Circle of 120 mm diameter at 2.5 m distance from the nozzle Distance from nozzle to enclosure surface: 2.8 m 	Pass

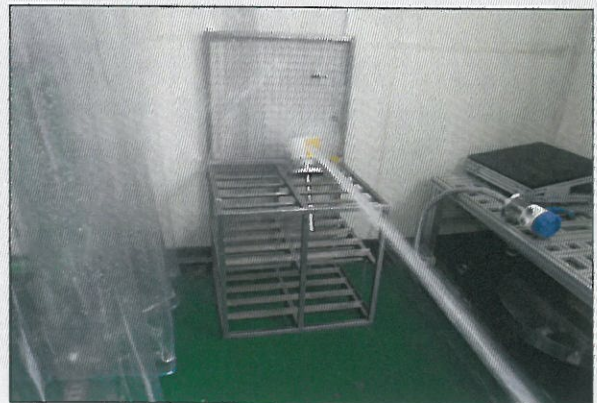
[Fig. 4: IP X6]

2.4 Water Test Contents <ul style="list-style-type: none"> Test duration: 3 min
